Operation Group Field Notes

Please find below the field notes from the Operations Group as part of the overall investigation into TACA flight 390. The purpose of the field notes is to provide initial observations and comments to support the overall investigation. The report does not provide analysis or conclusions.

TACA INTERNATIONAL Flight 390, Airbus A320, MSN1347, Registration EI-TAF

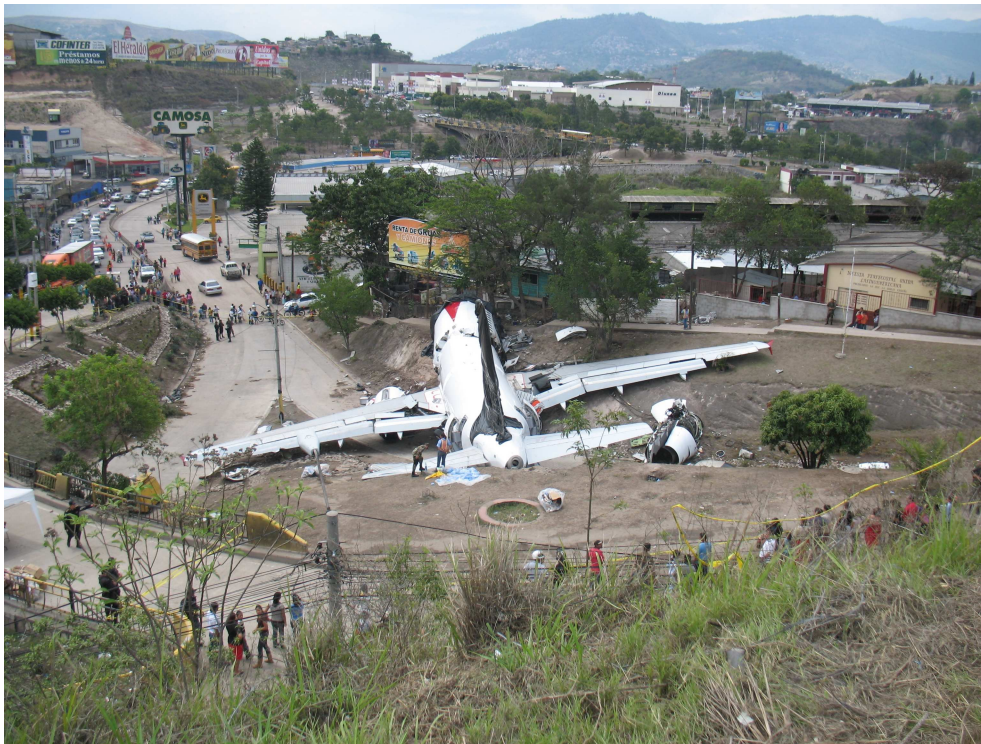
Photo 1

Accident site at Tegucigalpa

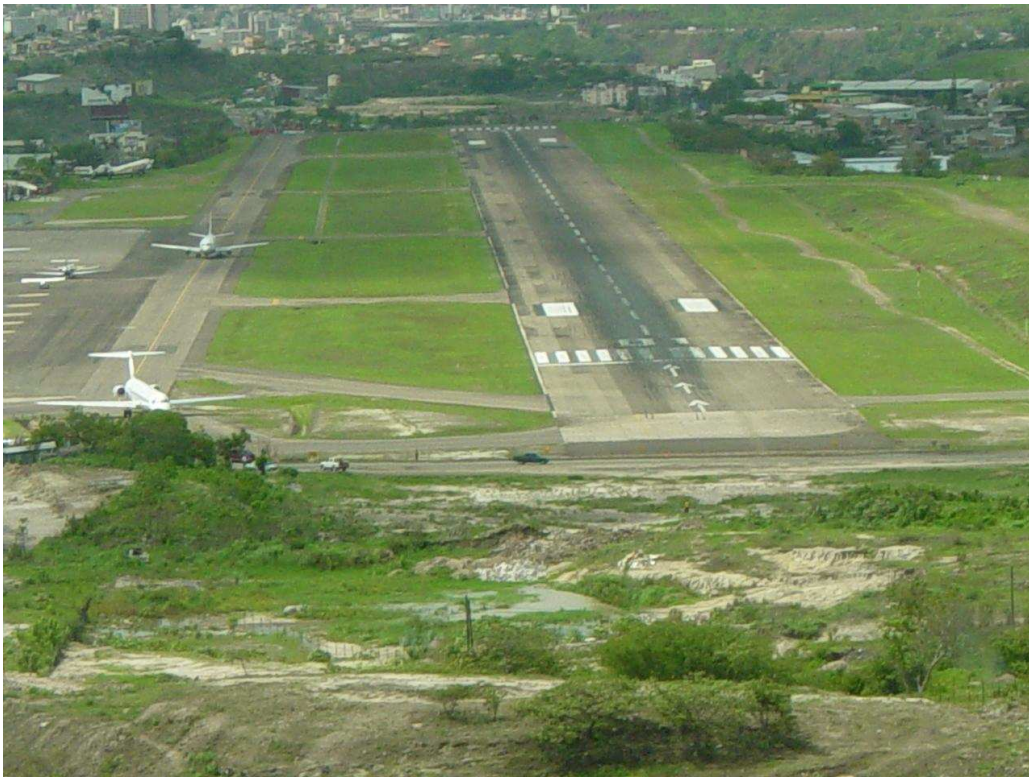
Photo 2

Runway 02
